IRON FILTRATION

DOES A STIRLING JOB IN BALCATT

ei ELLIOTT'S IRRIGATION Article by Elliotts Irrigation

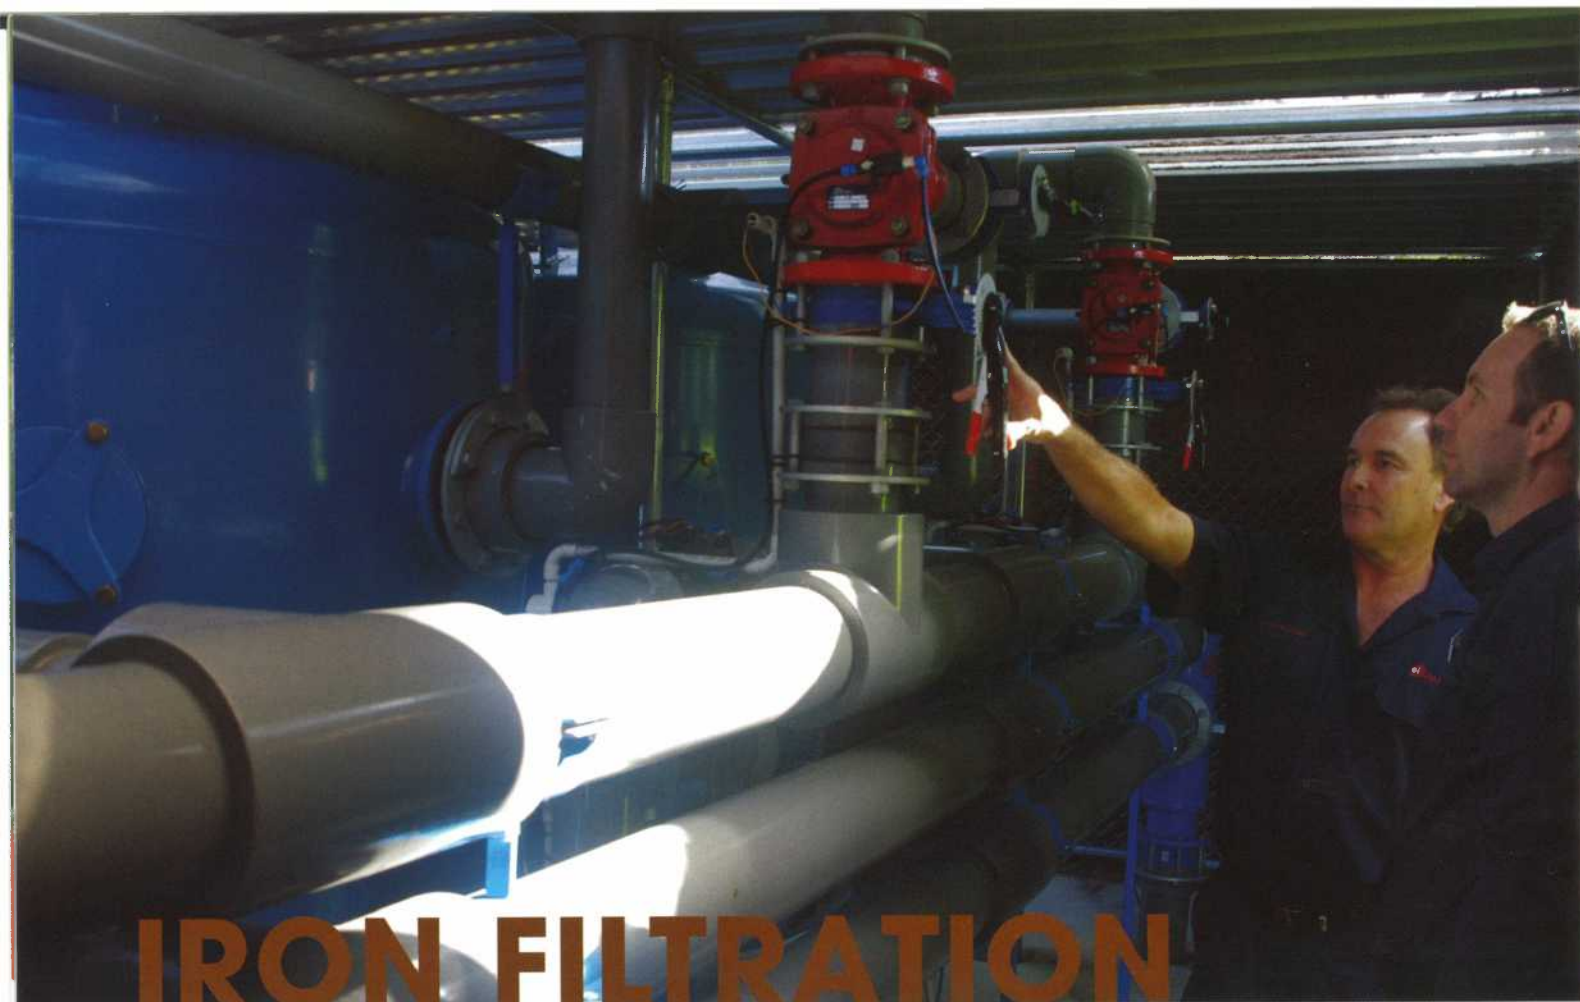
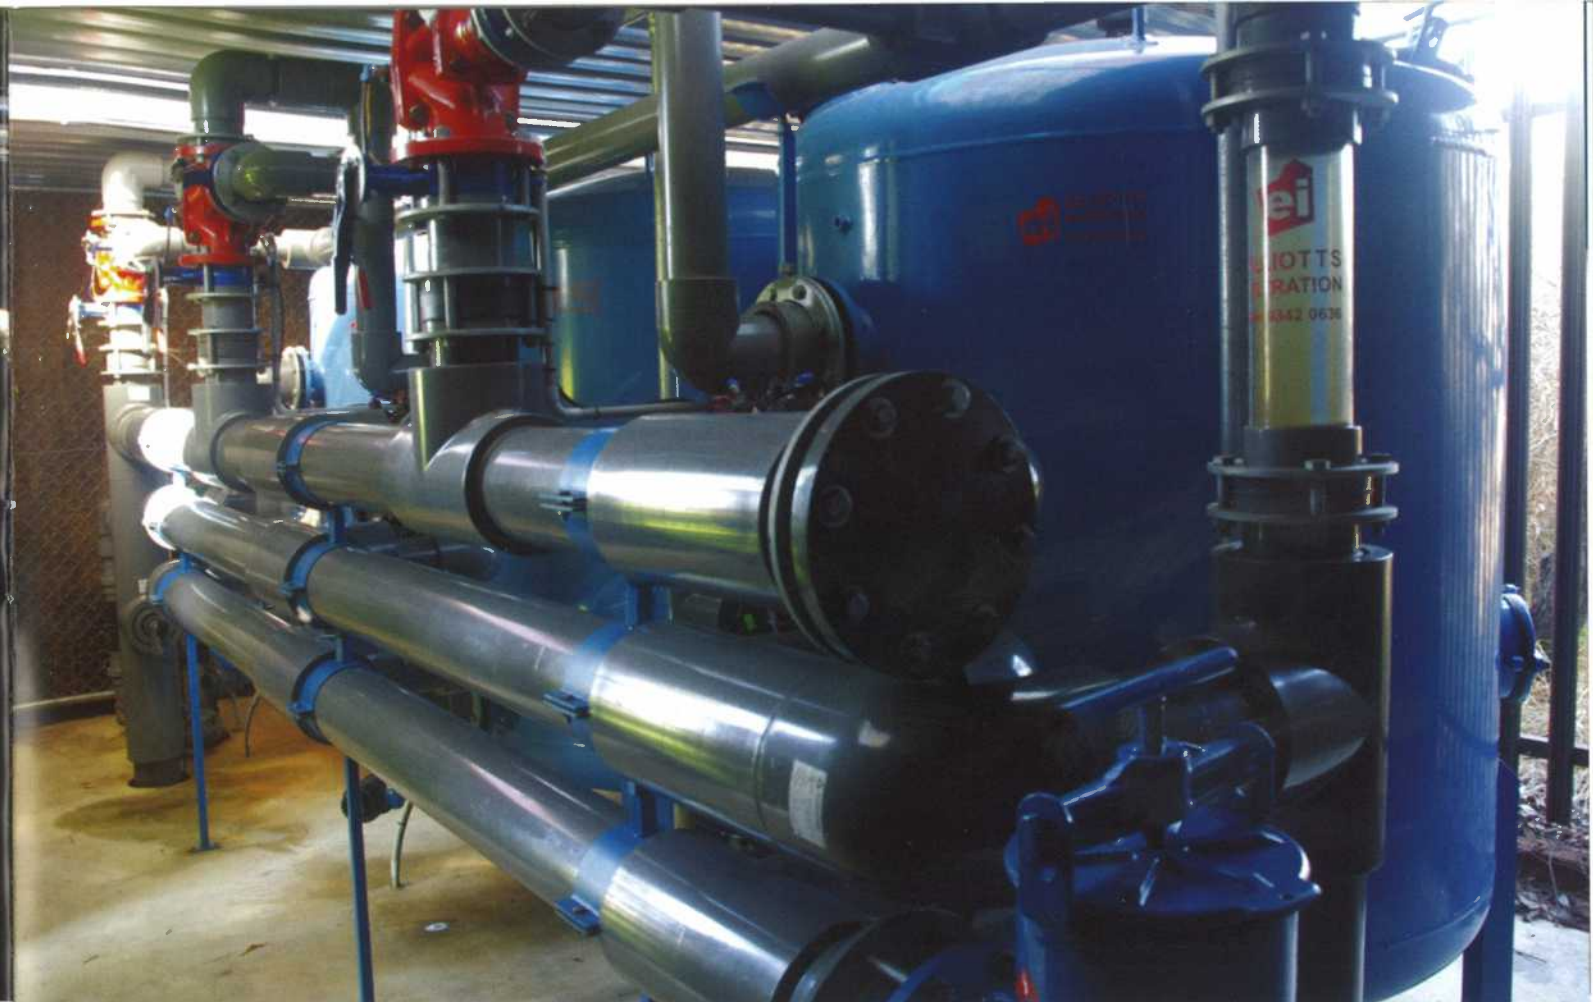
Kevin Zoccoli - Irrigation Services Supervisor and Mark Pipes, Elliotts Irrigation Filtration Manager inspecting the filter system at Vasto Reserve

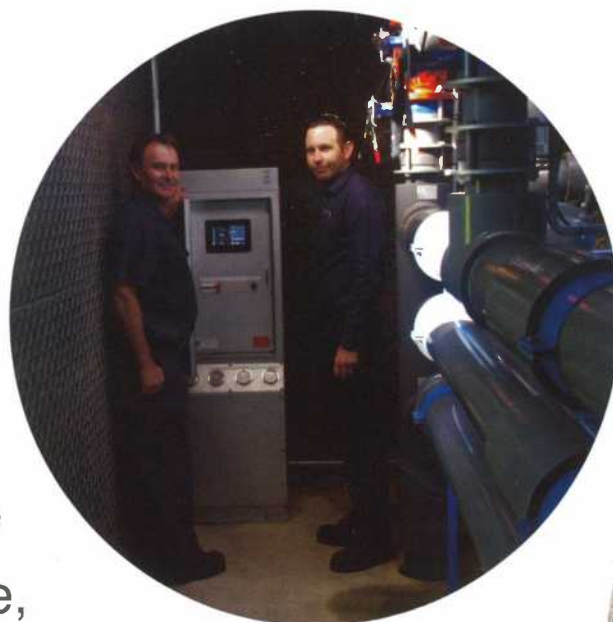
Above: Commissioning of the iron filter at Vasto Reserve, Stirling - WA

After the commissioning of the iron filter on the Vasto Reserve, the iron dropped to below 0.3ppm and has maintained this level for over 12 months. The dramatic reduction of the iron level has reduced the ongoing maintenance demands.

b) Filtration:- The oxidised water then passes through a naturally occurring catalytic media catching the precipitated iron.

The Vasto Reserve iron filtration unit is capable of removing iron for between 15 and 25 hours of service. This time frame is site specific with the unit being set to its own requirements. After the specified operation time the filtration system will automatically backwash using the bore water. This process rids the filter of accumulated iron effectively recharging it for its next operation period. A rinse stage cleans the filter before returning it to service.

The Iron Filtration process involves a unique method of removing soluble iron from groundwater without the need for large dropout tanks or chemical extraction procedures. The process of removing the iron is carried out through a two-part procedure:

a) Oxidation:- Air is injected through a venturi via a booster pump into the raw bore water. This starts the iron oxidation process.

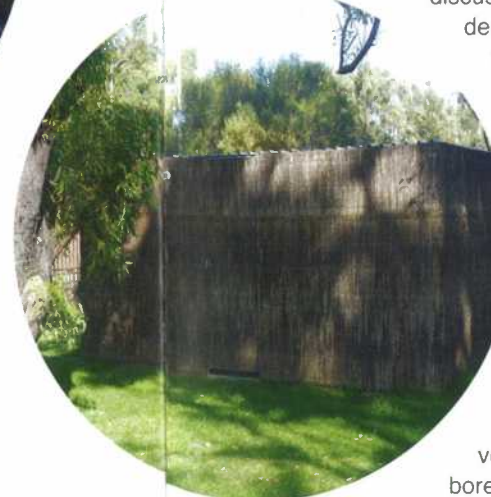
Above: Enclosure filtration system Vasto Reserve

Filtration enclosures have been adapted, and custom designed to blend in with the location and landscaping being it in a brushwood enclosure, custom built sheds/huts to colour coded aluminum or plastic slat encloses to mirror new estate architecture.

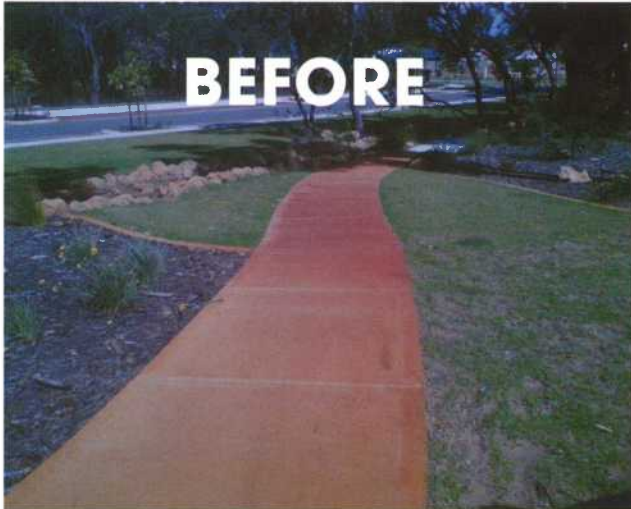
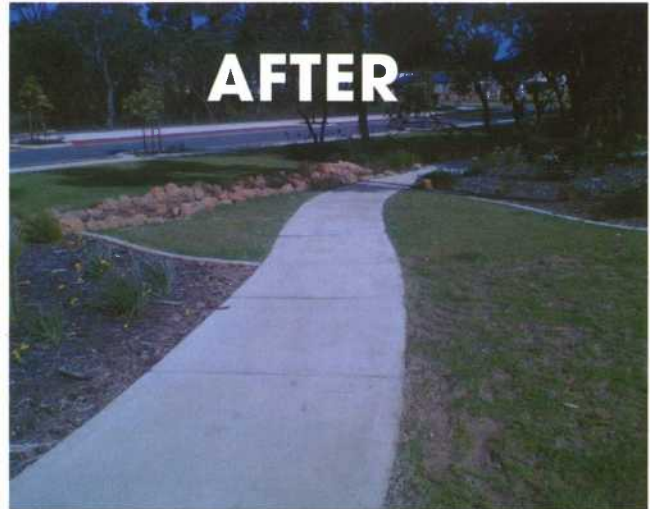
Above: The 'After' photograph was taken after the filter was installed and a stain clean carried out. The path remains clean after 12 months of running.

High Iron levels found in a sizable percentage of bore water in Perth can be a huge issue to those responsible for irrigation maintenance of large commercial projects. Water with high iron concentration is not only responsible for unsightly staining onto surrounding surfaces, but more importantly provides an environment for iron bacteria to grow which can cause breakdown of the watering system due to fouling of irrigation mainlines, blockages of sprinklers and failure of solenoid valves.
