Article by Elliotts Irrigation

OPTUS STADIUM BORE WATER IRON FILTRATION

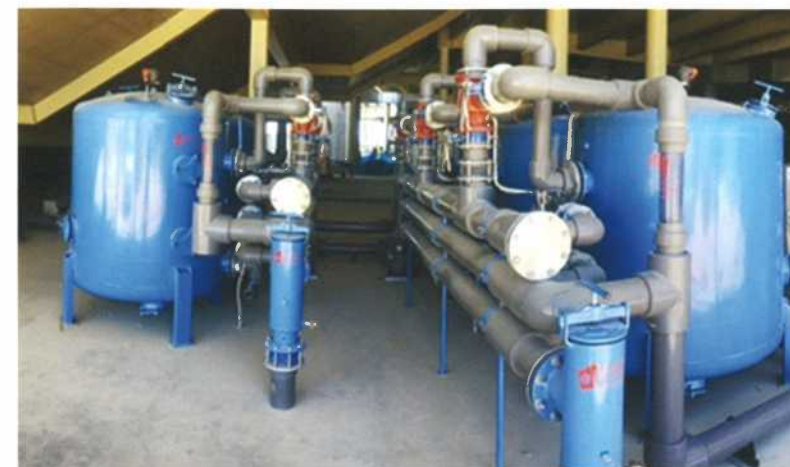
Above: Bore Water iron filtration system installed at Optus Stadium. Photo: Elliotts Irrigation

- a) Oxidation:- Air is injected through a venturi via an aeration pump into the raw bore water. This starts the iron oxidation process.
- b) Filtration:- The oxidised water then passes through a naturally occurring catalytic media catching the precipitated iron.

The Optus Stadium iron filtration unit is capable of removing iron for up to 25 hours of continuous service. After this time; the filtration system will automatically backwash using the bore water itself. This process rids the filter of accumulated iron effectively recharging it for its next operation period. A rinse stage cleans the filter before returning it to service.

After installation of the filter at Optus Stadium, the iron level dropped to below 0.3ppm and has maintained this level since commissioning over 12 month ago. The outstanding results of
